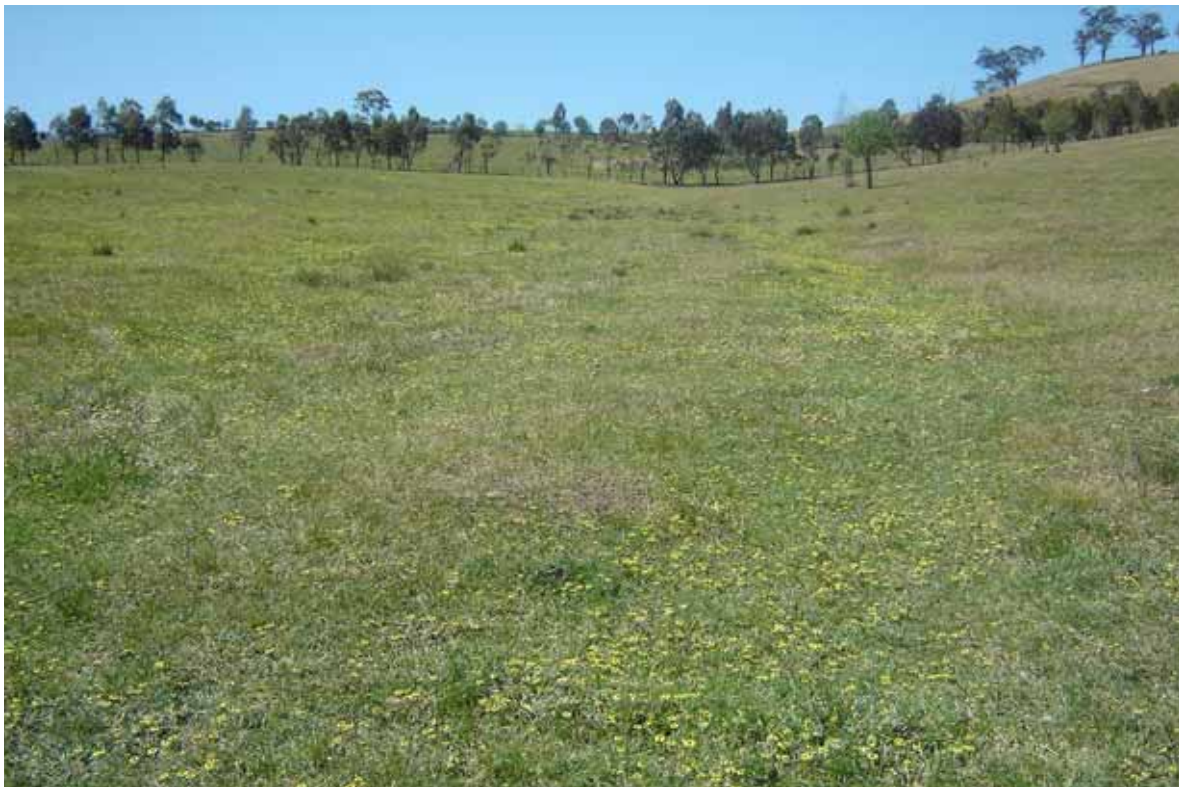
A large proportion of the waterways crossed by the different alignments can be categorised as unchannelled hillslopes (Figure 6, Table 8). Generally, these hillslopes are poorly connected with the channel system. Some of these hillslopes appear to have progressed through a past sequence of incision and gulying, but these hillslope hollows are now largely considered stable. The construction of dams in many of these hillslope depressions also reduces the potential for runoff. Landslip was identified as possible risk in the headwaters of Steels Creek and Dixons Creek (Waterway Crossings 136, 138, 148 and 149).

- **Figure 6 – Example of Unchannelled hillslope (Waterway crossing number 4). Refer to Appendix A for location.**

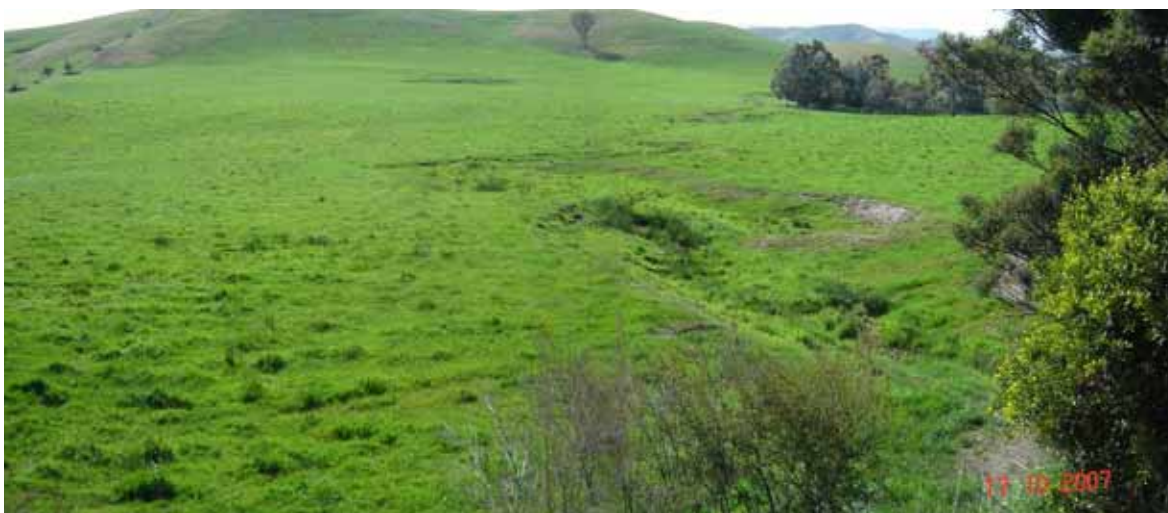
Gullying was identified at waterway crossing number 77, an unnamed tributary of Caraman Creek (Figure 7, Table 9). The gully is covered in part by grasses, however, the bed and banks are generally bare of vegetation. Revegetation can be seen in the distance, where the gully is more incised. Further investigations are recommended to determine if erosional headcuts are present in this vegetated zone, and their potential to migrate further headward and cause further incision in the area between the revegetation zone and the Melba Hwy.

- **Figure 7 - Photograph looking downstream from Melba Hwy at Waterway crossing number 77. Gully partially covered by grasses (Refer to Appendix A for location).**

Waterway name	Land system ¹	Crossing number (Designated waterway number)	Risks
Unnamed tributary. Of Caraman Creek	1.1HsP7-2	77	Possible headcuts in vegetated section downstream

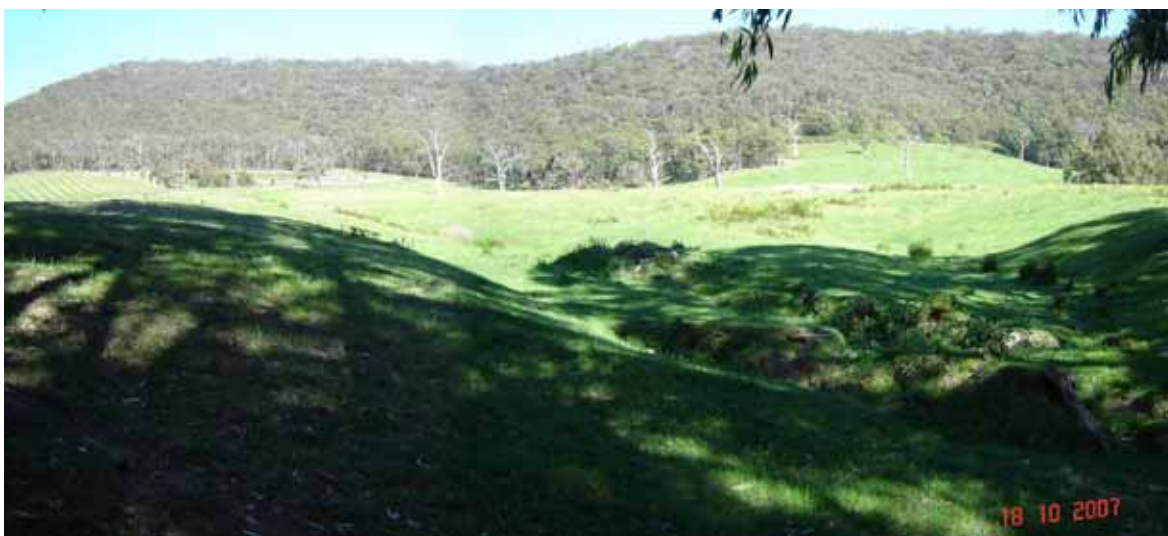
The pipeline does not cross a significant number of confined headwater reaches. Only two waterway crossings which fall into this class were identified, both of these being unnamed tributaries of Dixons Creek (Figure 8, Table 10). Landslides were identified as a possible risk at one of these sites, waterway crossing 143. Further detailed studies at this site by a geotechnical engineer are recommended.

- **Figure 8 – Photograph taken looking upslope at waterway crossing number 143 (Refer to Appendix A for location of waterway crossing).**

Waterway name	Land system¹	Crossing number (Designated waterway number)	Risks
Unnamed tributary. Of Dixons Creek	1.1LsP7-3	141, 143	Possible landslides - 143

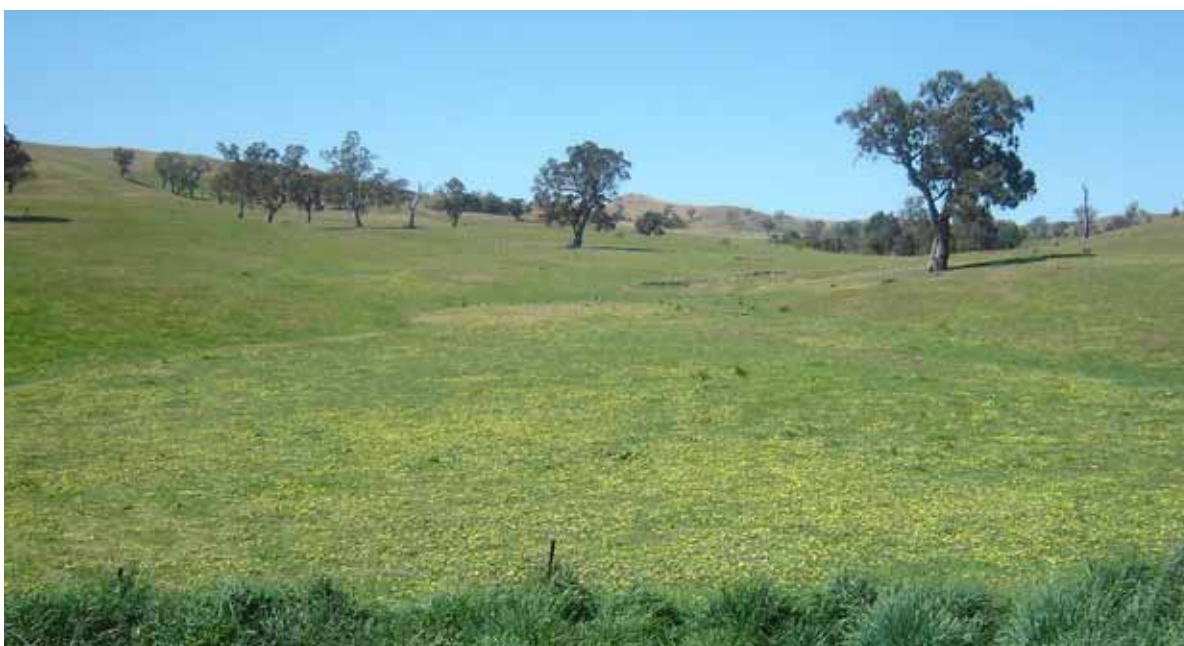
Unchannelled valley fill occurs where the river flows inefficiently through poorly drained swampy areas. In these reaches there are multiple flow paths with no discernible banks. Eroded material from further upstream is not transported through this reach. As the gradient steepens downstream, channelled flow occurs again. A significant number of the waterway crossings assessed are classified as unchannelled valley fill reaches (Table 12). In some cases, it was evident that road has acted as a barrier forcing deposition of sediments upstream and the formation of these unchannelled valley fills (for example Waterway crossing 3 as shown in Figure 9).

- **Figure 9 - Sedimentation forming unchannelled valley fill upstream of road at Waterway crossing 3 (Refer to Appendix A for location of waterway crossing).**

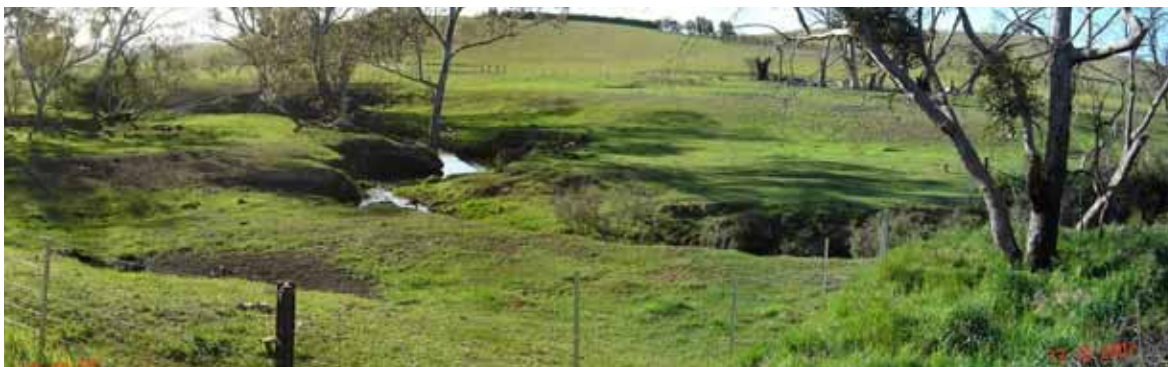
■ **Figure 10 - Rellimeiggam Creek.**

A large number of the waterway crossings traverse meandering reaches (Figure 10, Table 13). These meandering watercourses vary greatly in the character, many have been significantly disturbed as a result of changes in land use (vegetation clearing) and drainage works. Lateral movement of meandering channels across their floodplain is a fundamental property of channel types. Clearing of vegetation from the floodplain and channel banks is likely to have accelerated rates of lateral channel migration.

A number of meandering waterways also appear to be actively deepening (Ewing Creek, Caraman Creek, Dixons Creek, Eaglenest Creek and Steels Creek). It is recommended that longitudinal surveys are carried out using differential GPS, surveying in detail changes in bed level to ascertain the location and size of headcuts and their potential for further headward erosion. This is important for determining the minimum depth at which the pipeline can be laid below the channel so that it is not exposed through future headward erosion of the channel bed.
